Regulatory Information Report

RIRF24127

**Fire resistance test for penetrations through a
vertical separating element**

Test method: AS1530.4-2014

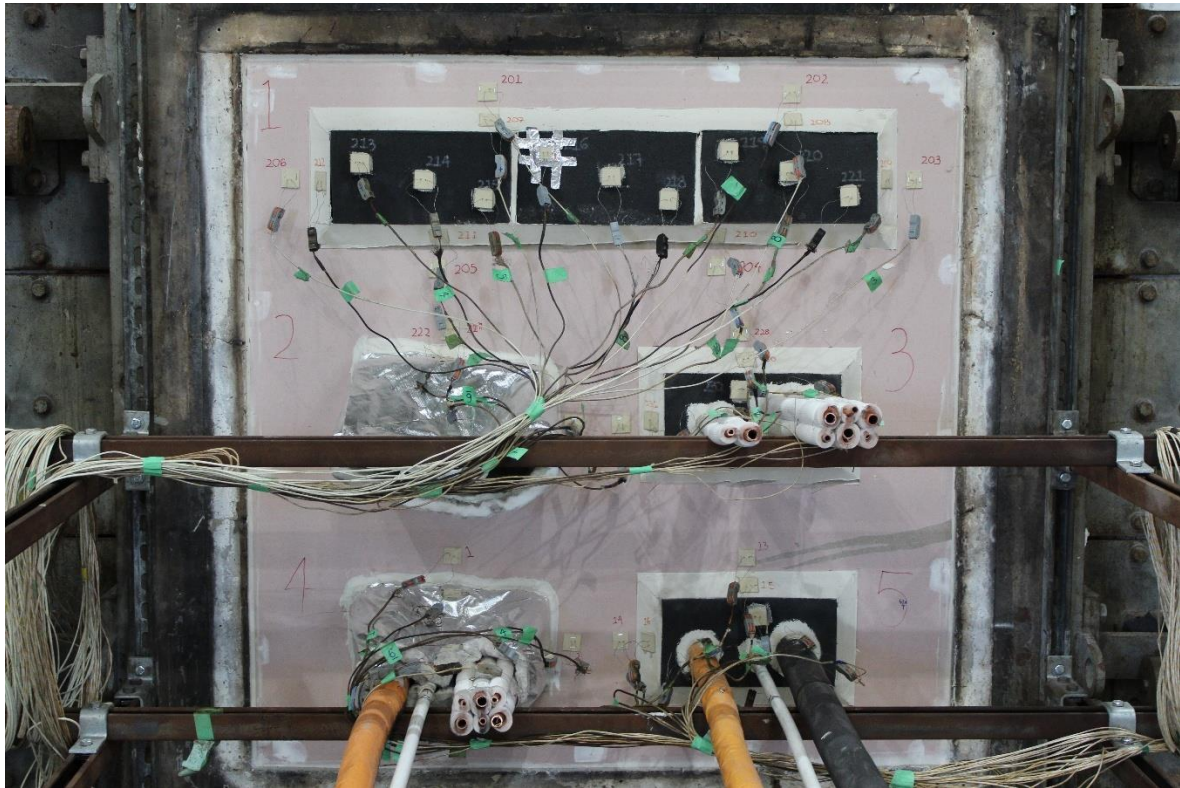
Figure 1 – Unexposed face prior to test commencement

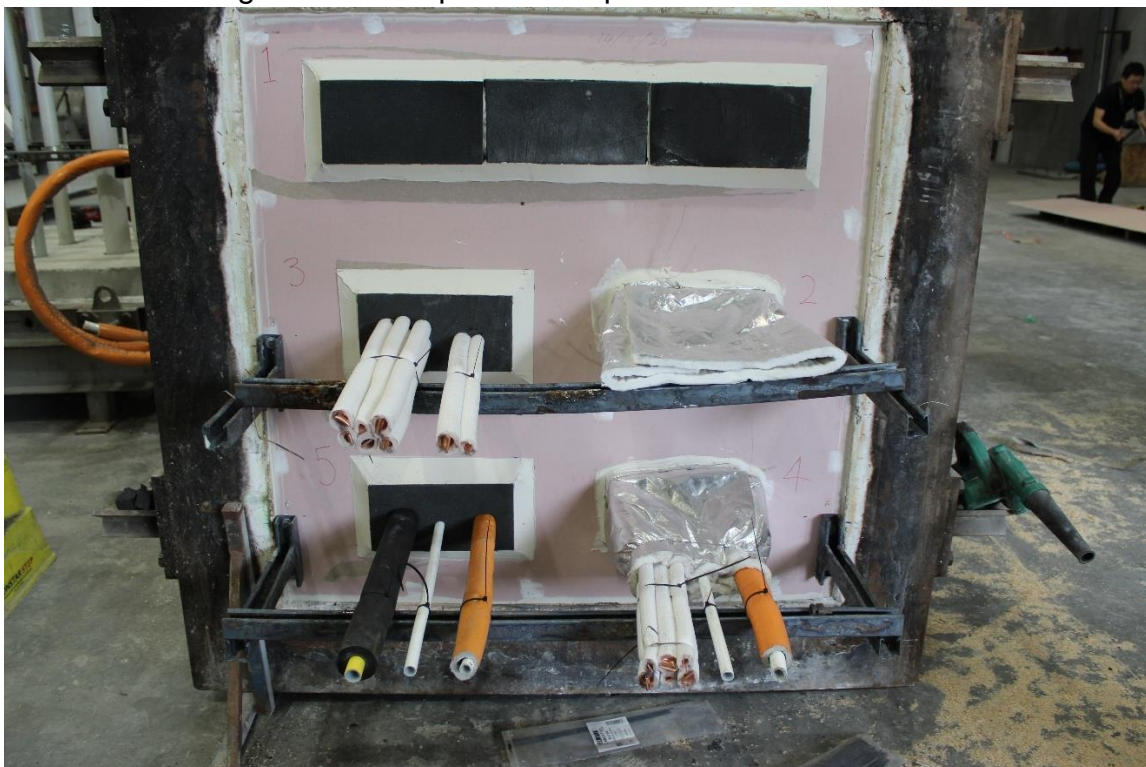
Figure 2 – Exposed face prior to test commencement
