FIRE RESISTANCE TEST REPORT

Test standard: Sections 2 and 10 of AS 1530.4:2014

Products: Agnitek fire collars and sealants protecting various penetrations in a 2 hour fire-rated wall system

Job number: FRT251395

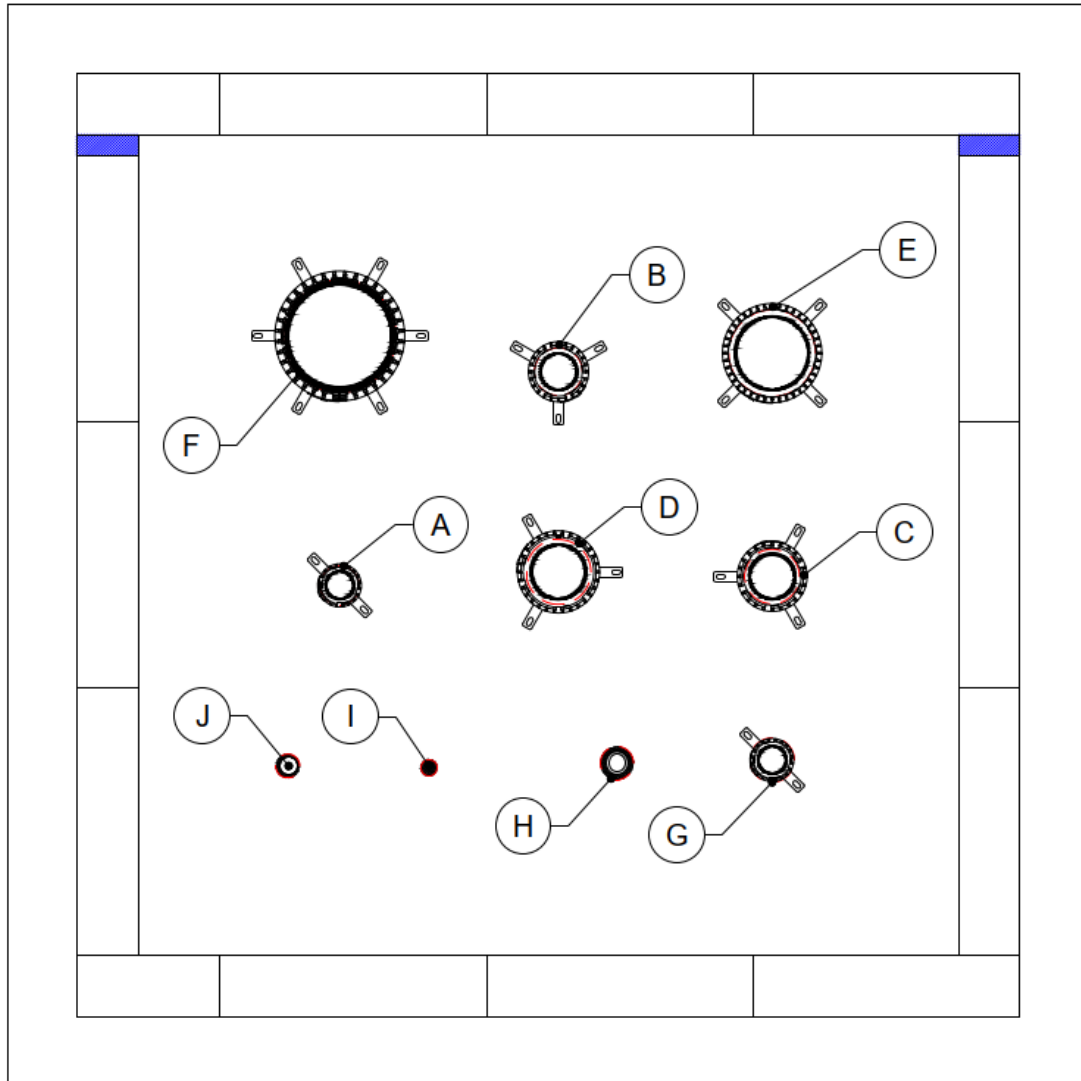
Figure 2 Elevation view of test specimens (exposed side)

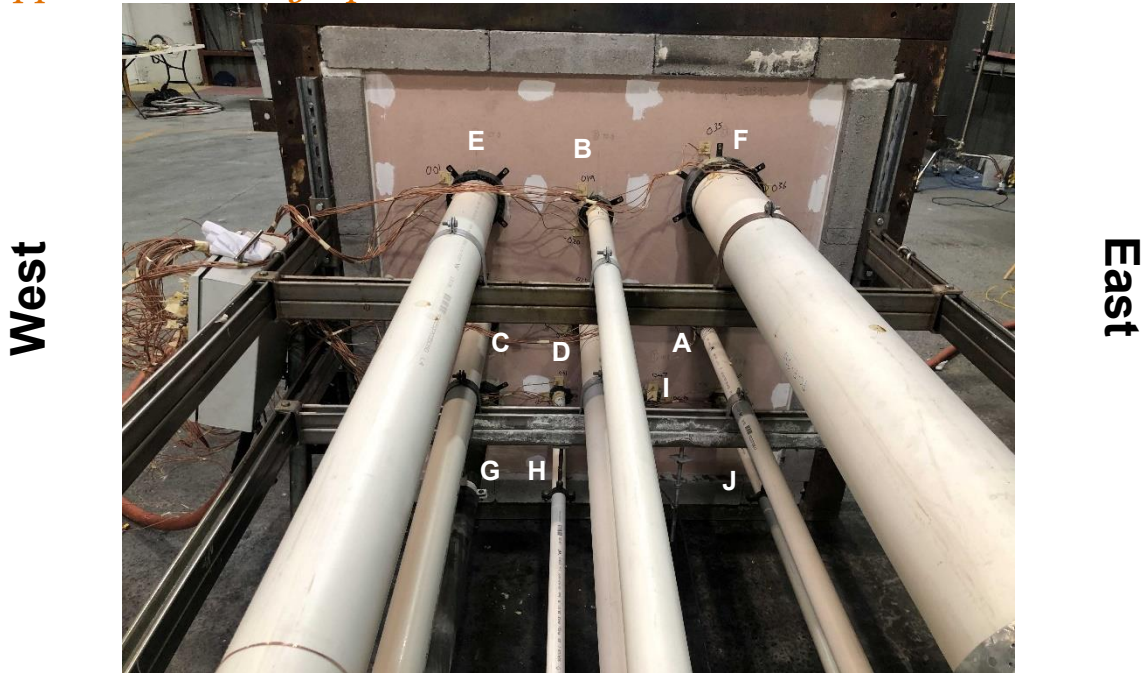
Figure 32 Unexposed face of the specimen before the test

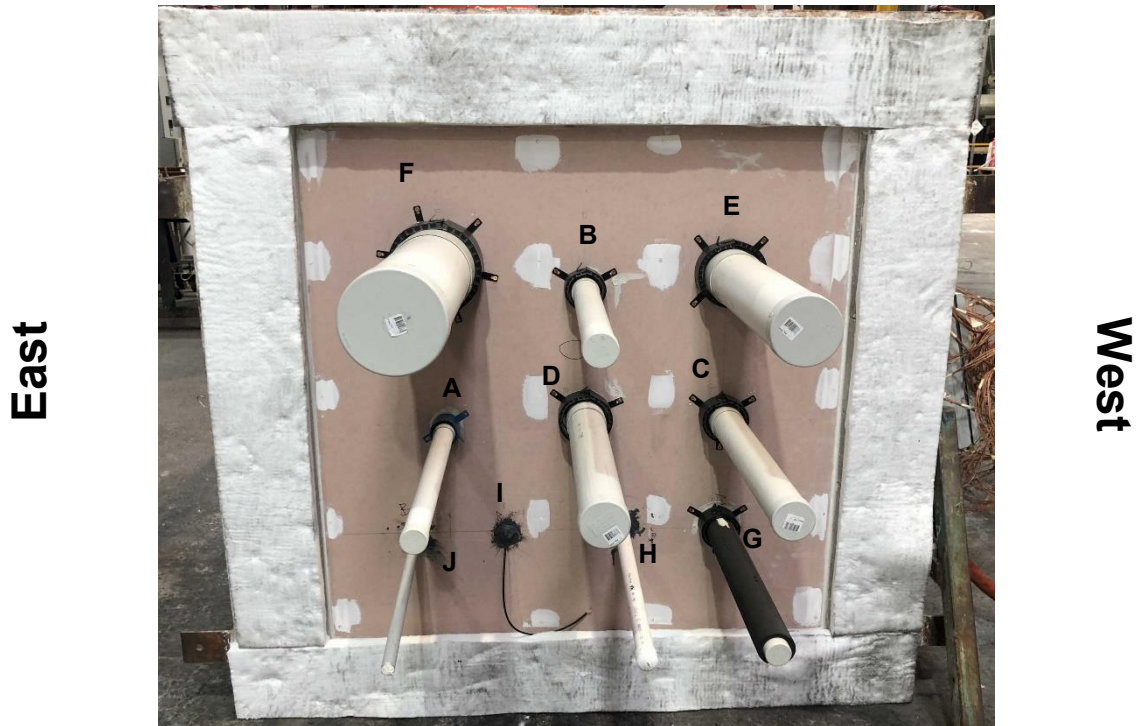
Figure 33 Exposed face of the specimen before the test

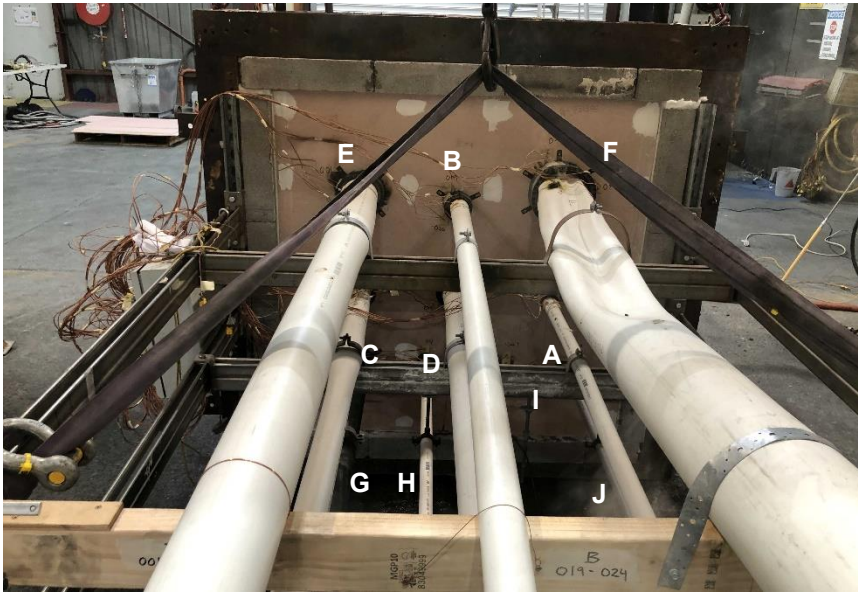
Figure 34 Unexposed face of the specimen at the end of the test
